# Where are the Shipwrecks of the Zuiderzee?

## A new version of the Shipwreck Database Flevoland (3.0), based on spatial and archaeohistorical research into wreck sites in the province of Flevoland

Y.T. van Popta & A.F.L. van Holk

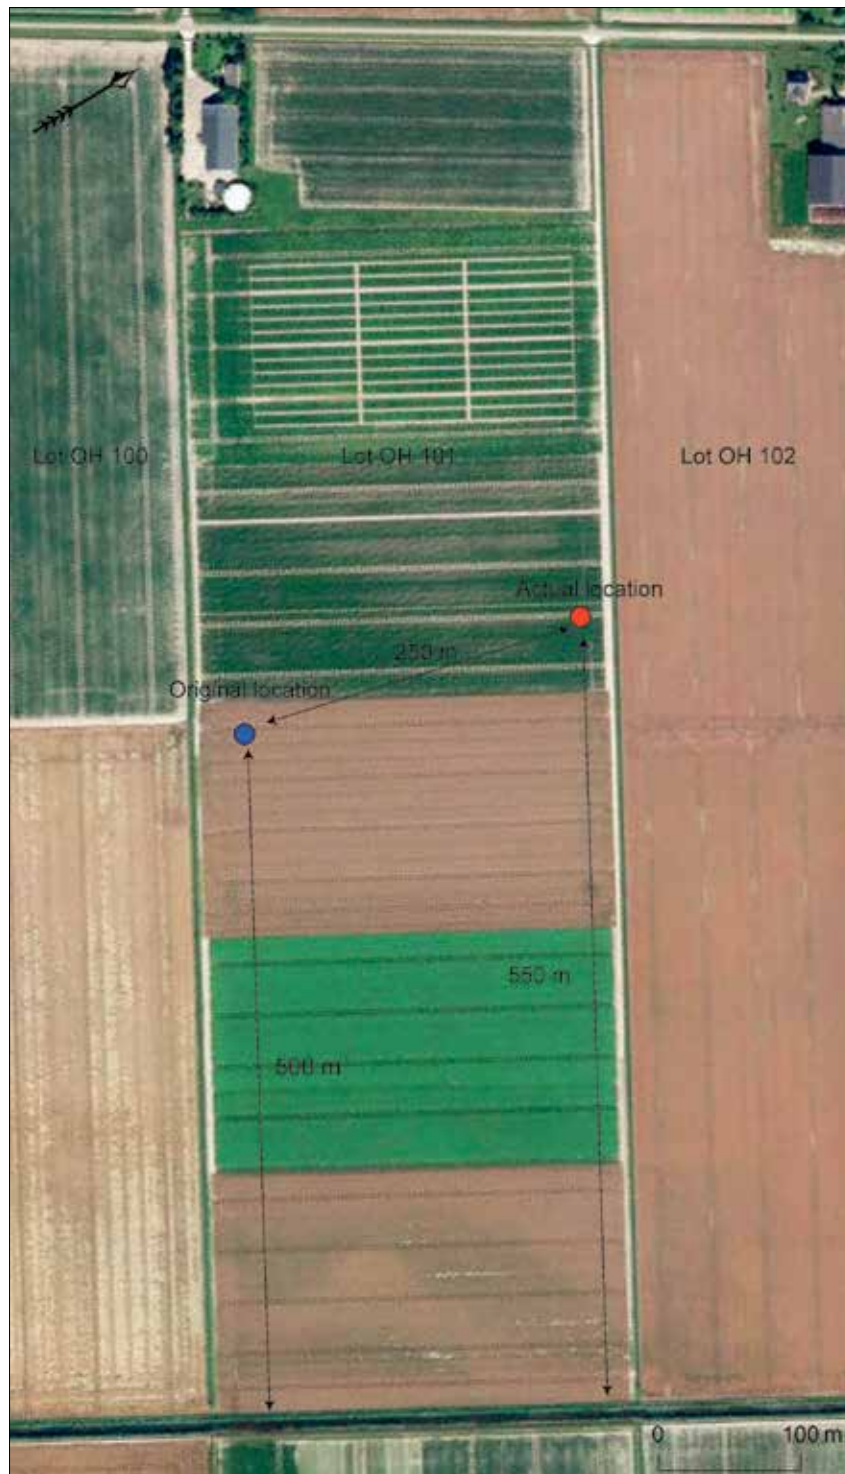
Fig. 5. An example of a misinterpreted shipwreck location. Originally, the wreck was marked close to the ditch that separates lots OH 100 and OH 101, while it should be close to the ditch that separates lot OH 101 from lot OH 102 (Y.T. van Popta, RUG/GIA).

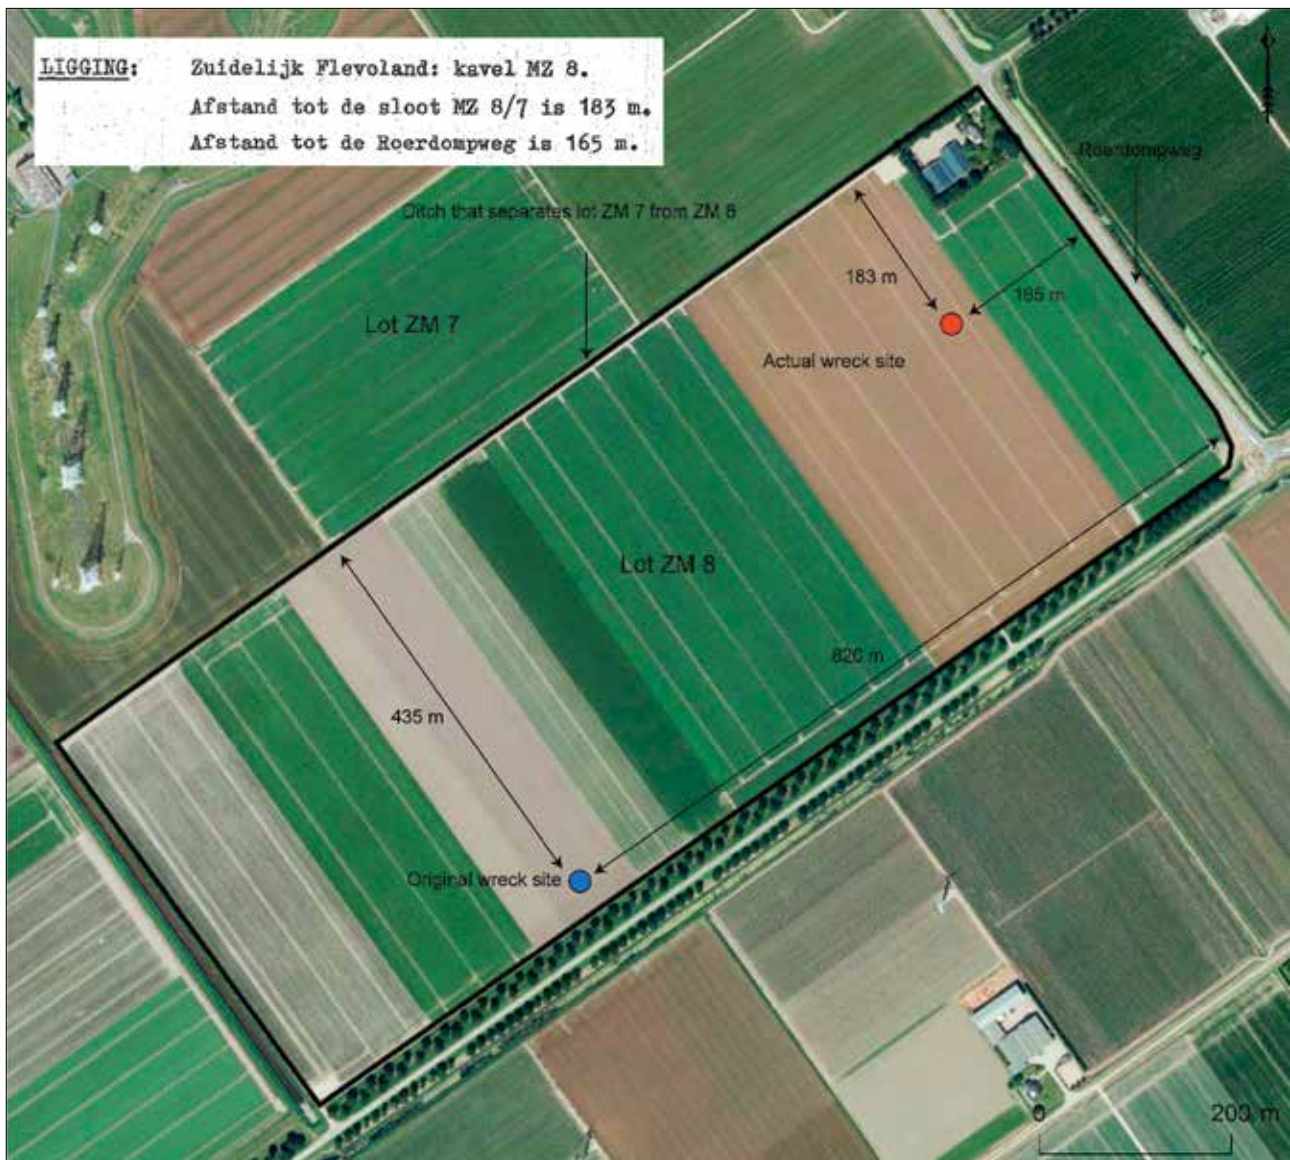
Fig. 6. This figure shows the actual wreck site of shipwreck ZM 8 (red dot) and its recorded location (blue dot). The use of random coordinates, while an accurate wreck site description was available, caused a deviation of 700 m (Y.T. van Popta, RUG).

The use of random or approximate coordinates has caused the largest number of deviating wreck locations in Flevoland. In total, 149 wreck locations have been adjusted with a total error distance of almost 30 km (table 2). If we look at the deviation for individual wreck sites, it is clear that the majority (60%) have an error of less than 200 m. A total of 32 wreck sites required only small adjustments (a maximum of 50 m) to their location, for example when coordinates were used of a fixed point in the direct proximity of the shipwreck (e.g. corner of excavation trench), instead of the centre of the actual wreck. The average deviation amounts to almost 200 m. The majority of these deviations are caused by the fact that at the beginning of the digital era, for example for the development of the national database Archis, many coordinates were estimates. The question is why approximate or even random coordinates were used to indicate wreck locations instead of accurate positioning. The lack of a systematic approach and the availability of only very basic digital tools seem to cover one side of the explanation. Furthermore, wreck locations might have been digitalized from distribution maps on paper, whose accuracy is limited to the regional level (scale 1:50,000). In general, the wreck locations on these maps are represented by drawn dots whose diameter in itself represents 50 to 100 m. Thus the scale of the first paper maps also partially determines the accuracy of later digitized maps. However, it does not explain why in some cases shipwrecks seem to have utterly random coordinates. This may be illustrated by the case of shipwreck ZM 8: the location of the wreck site is described as “183 m from the ditch that separates ZM 7 and ZM 8” and “165 m from the Roerdompweg road”, which should be in the northeastern part of the lot (fig. 6). For some reason, the wreck location according to Archis and the Ship Catalogue is shown in the southwestern part of the lot, 435 m from the ditch that separates ZM 7 and ZM 8, and 820 m from the Roerdompweg. The official report even provides the correct coordinates of the wreck site, but these were ignored in both databases. As a result, a deviation of 700 m existed between the charted wreck site and its actual location.

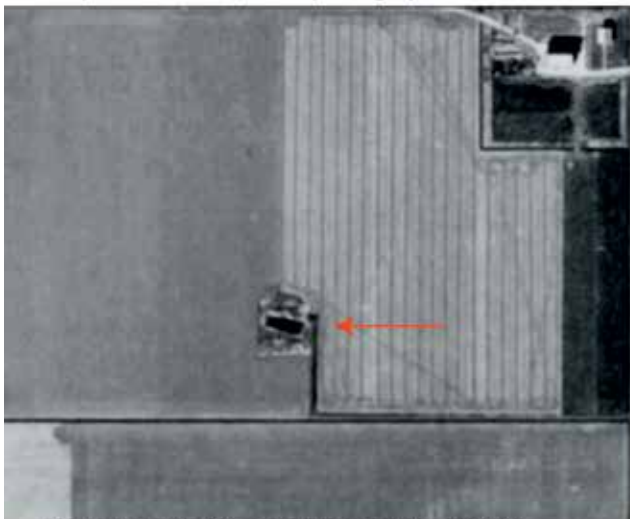
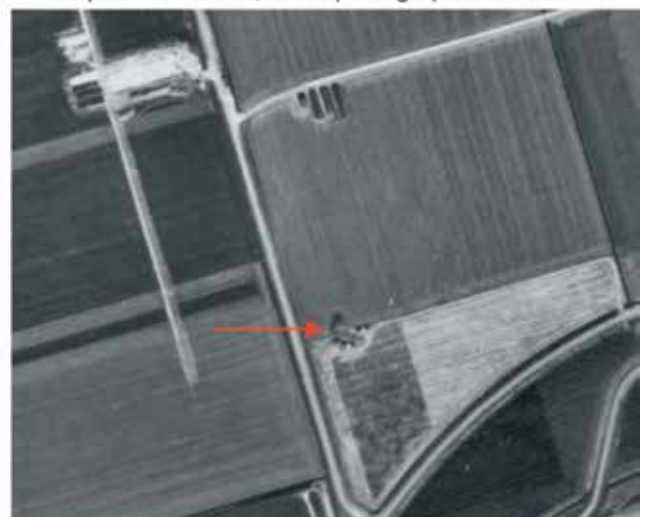
Fig. 7. Six examples of excavation trenches that are clearly recognizable in historical aerial photographs (Y.T. van Popta, RUG/GIA; aerial photographs: Province of Flevoland).

ways. First of all, some aerial photographs show shipwreck excavation pits as the photographs were coincidentally taken during archaeological research. At least 15 excavation pits are visible in aerial photographs, of which 6 can be seen in figure 7. A close study of aerial photographs might even yield more visible excavation sites (an exercise which has not yet been undertaken). Secondly, wreck sites may also be visible as discolorations in aerial photographs (fig. 8), especially as soil marks, when the land was ploughed for the first time before any planting of crops. The soil marks are often caused by the disturbance of sediments near the wreck site due to (post-)depositional processes. For example, the wreckage of a ship can cause a turbulence in the water when the wreck sticks out of the seabed. As a consequence, quite large amounts of sand and shells

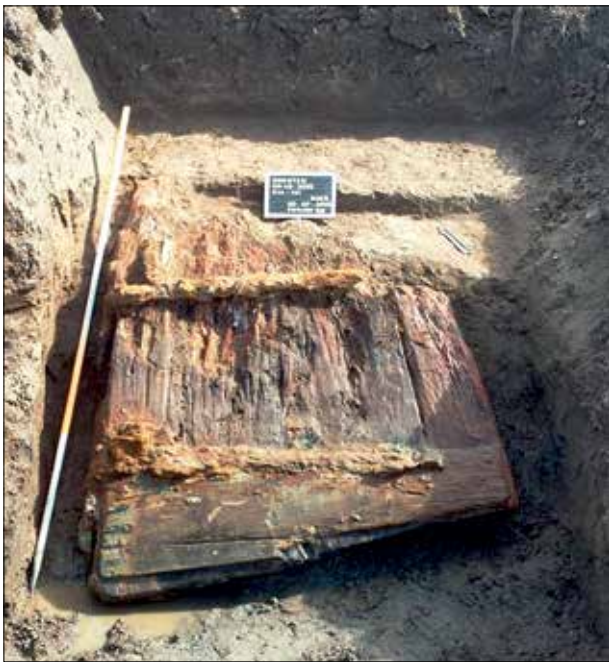
Fig. 10. The largely intact and well-preserved rudder of shipwreck OR 49 that was discovered outside the excavation trench (Y.T. van Popta, RUG/GIA).

was carried out to test whether any wreck parts would be visible on the maps generated from the geophysical data. As the results came in late, it turned out that multiple anomalies (parts of the wreck) had been located outside the excavation trench (in part caused by the fact that the trench is kept as small as possible, to minimize disturbance of farmland). More or less the same thing happened during the excavation of the 17th-century shipwreck OR 49 in 2015. At the end of the excavation campaign, the immediate surroundings of the excavation trench were examined with a metal detector. A strong signal was picked up close to an edge of the trench and it was decided to excavate that area as well. It turned out that the signal came from metal fittings and pintles (*roerhaak*) that were part of the largely intact rudder of the ship (fig. 10). Rudders are not often

found as they easily get detached from ships during the process of foundering. This specific rudder also became disconnected from the ship but sank quite close to the wreck. If the archaeological research had been limited to the trench, this rare and relevant part of the ship would have been missed. Furthermore, it is likely that objects from the ships' inventory are taken by the waves during wreckage and therefore are spread around the wreck site. The most obvious way to illustrate this is by looking at the eroded and disturbed sediments (*verspoelingslaag*) that surround shipwrecks: they often contain all kinds of objects belonging to the ship's artifactual inventory. This was also observed during the IFMAF campaigns when dozens of objects were found outside and even underneath the wrecks. The main point is that even if the documentation mentions that a shipwreck has been removed after archaeological research, there is a chance that structural parts and objects belonging to the ship's inventory still remain in the vicinity. Therefore, shipwrecks with a presence-absence score of C (removed) should be interpreted as: "the shipwreck was removed, but this is still a wreck site". So from a management point of view we should pay attention to these sites too. A distinction could be made between sites that have been excavated and afterwards left alone and sites that have been destroyed.

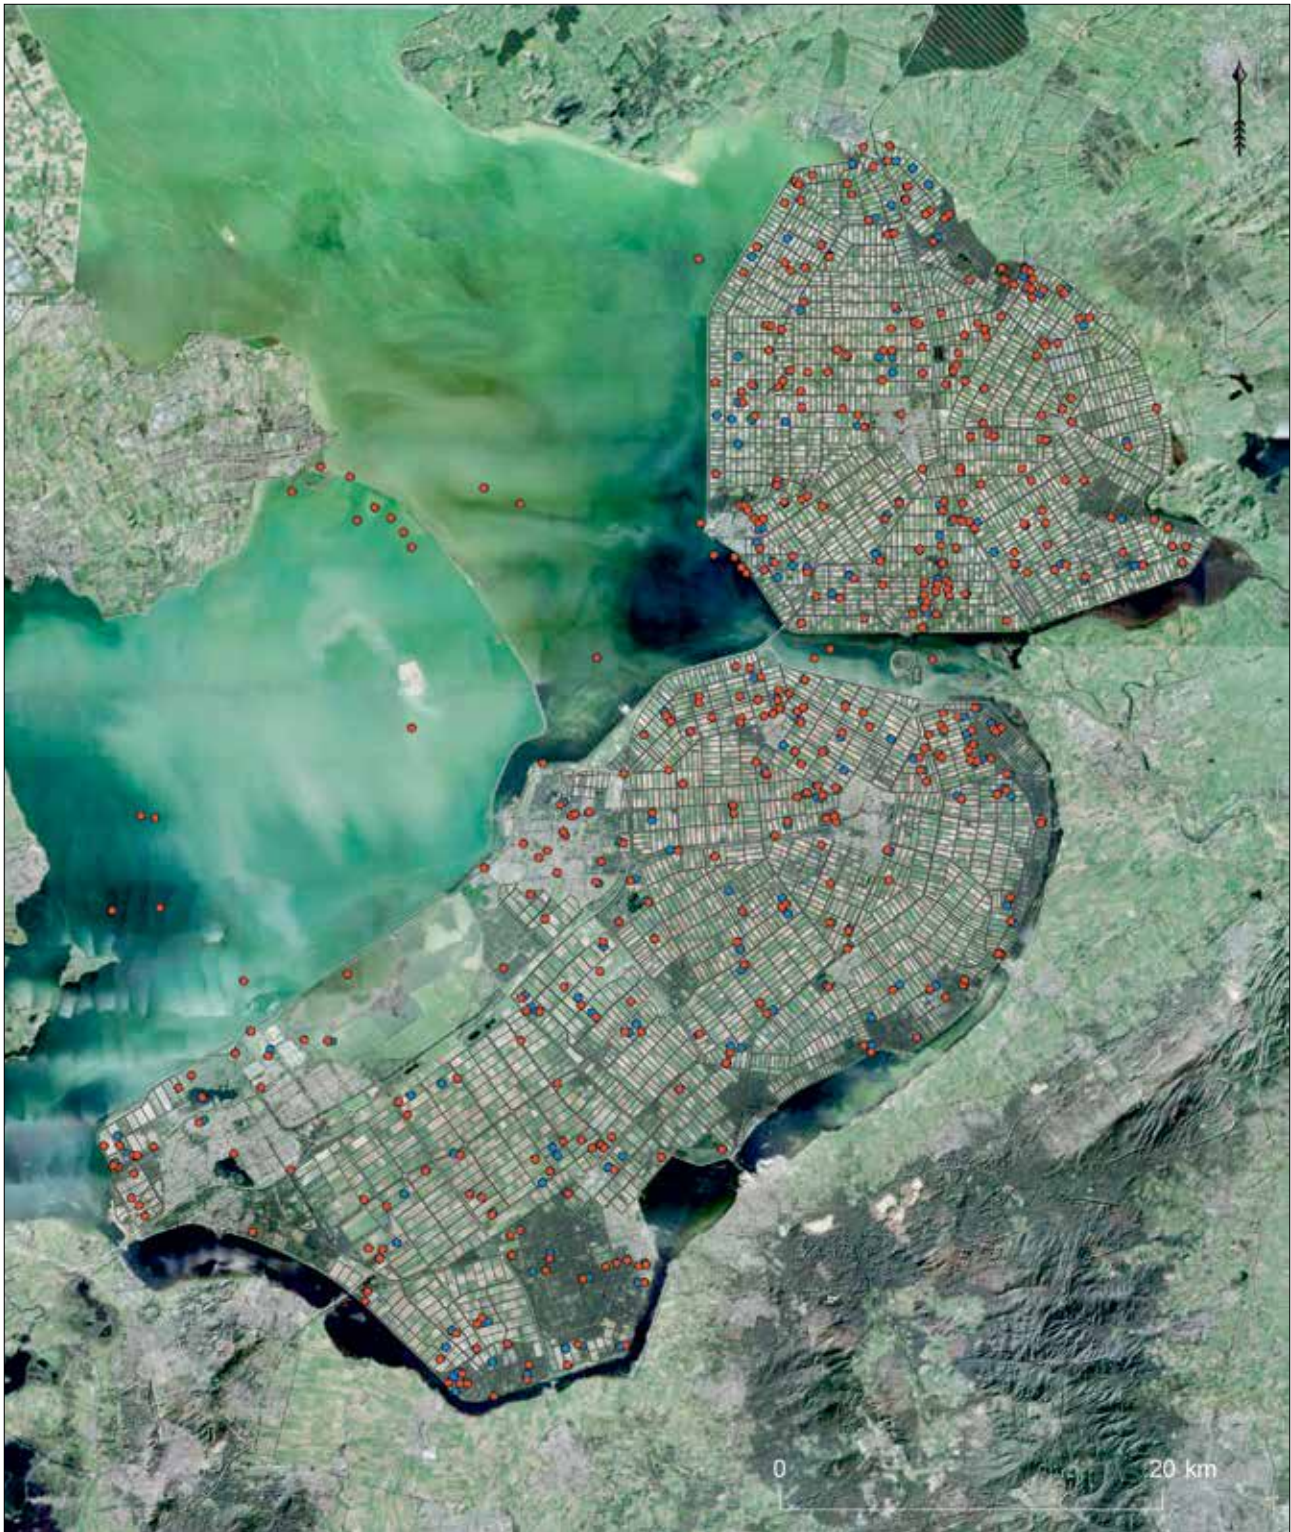
Fig. 12. Distribution map of shipwrecks in Flevoland. The blue dots represent wreck sites of the SDF 2 that proved incorrect or spurious, the red dots represent the wreck locations of the SDF 3 (Y.T. van Popta, RUG/GIA).
